**AFRL-ML-TY-TR-2004-4548**

**Performance Effectiveness Testing of the  
Expeditionary Fire Suppression System; Phase II**

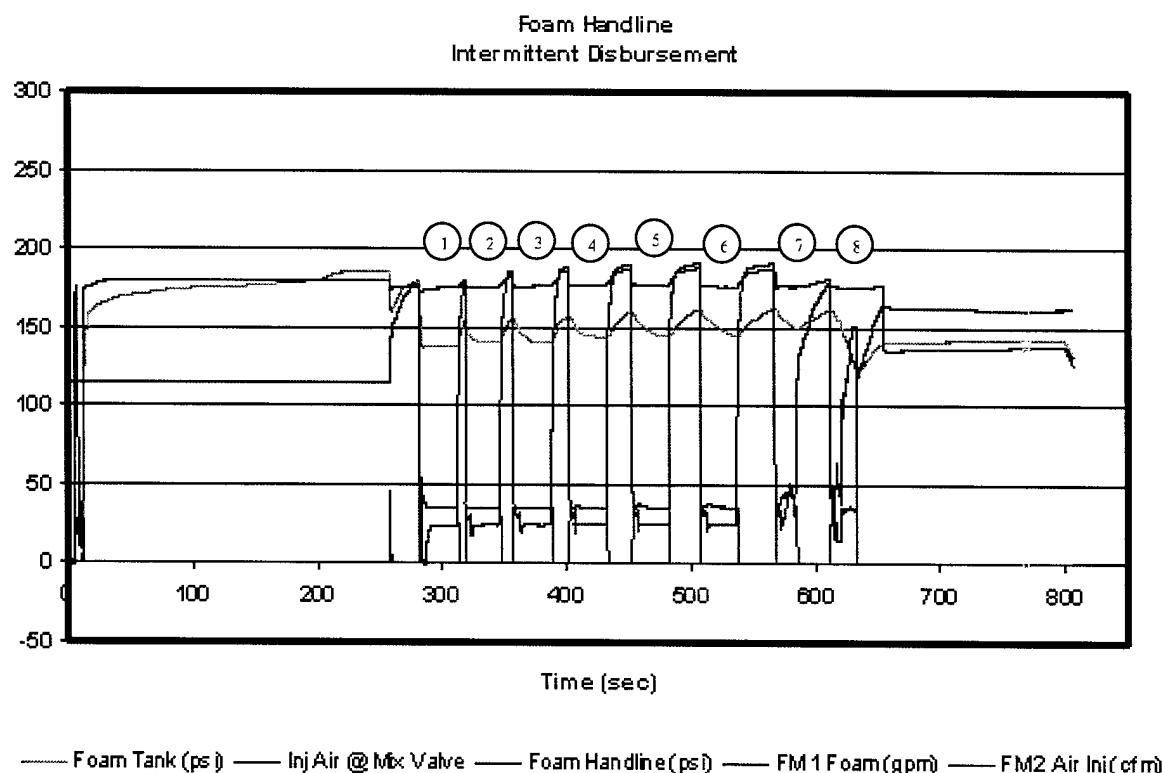
**Figure 2. Handline Foam Flow and Pressure Data, Intermittent Disbursement.**

Figure 2 shows the pressures and flow rates prior to the change of regulators. The foam tank pressure, during flow and non-flow periods increased over the duration of the test. During flow periods the foam tank pressure was approximately 30-40 psi below the set pressure of the regulator (138 psi, phase 1, to 151 psi, phase 5). The injection air pressure prior to flow was 180 psi, although it was set before the test to 190 psi. The injection air stayed relatively constant during flow periods, between 175 and 178 psi. The pressure at the handline functioned normally at 25 psi during flow periods and 175 psi during non-flow periods. The foam flow rate was approximately 35 gpm for each phase. No injection airflow was recorded for this test. The injection air flow meter was tested and a visual inspection at the nozzle was performed. This indicated a flow less than 2.5 cfm, which was the low-end of the flow meter and confirmed that the flow meter was working correctly and little air was coming out of the nozzle.

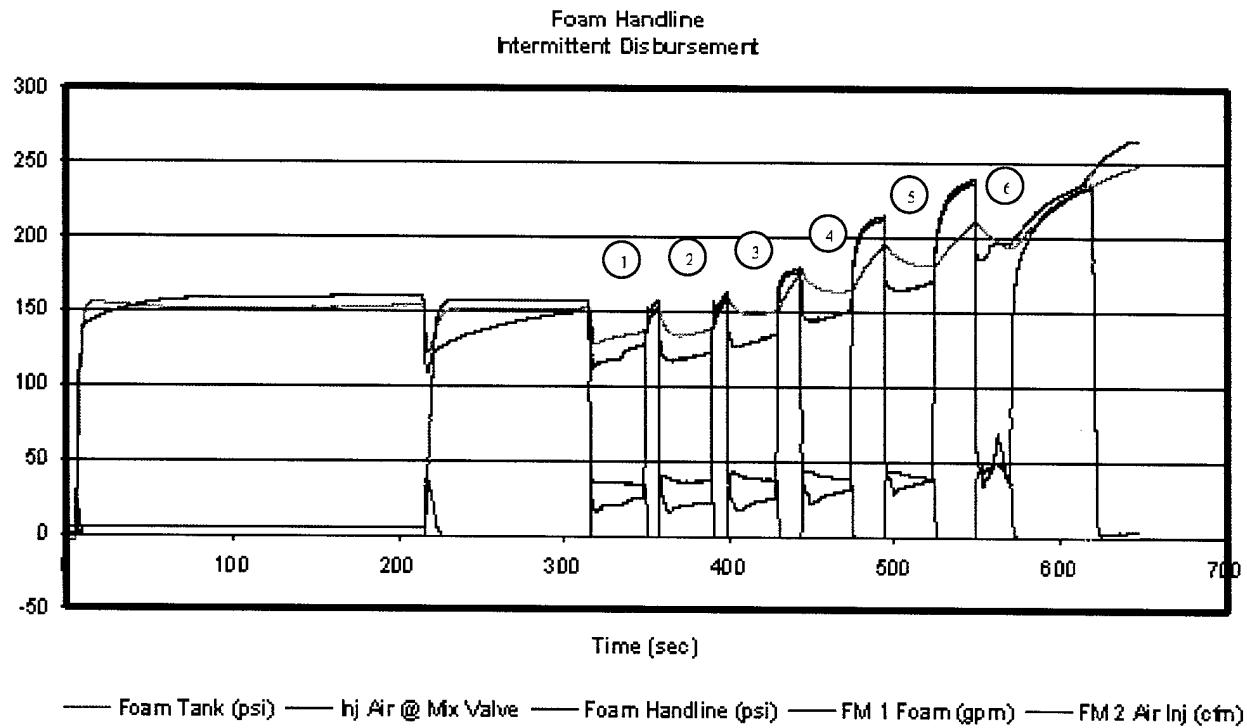
**Figure 3. Handline Foam Flow and Pressure Data, Intermittent Disbursement.**

After the regulators were changed problems continued with the regulation of pressures and the system charging slowly. Also, new problems developed, such as pressure build-up and sudden pressure loss at the foam air tank developed during flow. The same manufacturer settings were kept after the new regulators were installed (foam at 185 psi, injection air at 195 psi). Figure 3 shows the pressures and flow rates after the regulators were changed. Prior to this test, neither the foam tank nor the injection air pressures were reset. When testing began, the foam tank and injection air pressures were 154 and 160 psi respectively. The foam tank pressure during flow periods increased over each phase with a beginning pressure of 129 psi and an ending pressure of 194 psi. The pressure of the foam tank during non-flow periods increased from 151 psi, phase 1, to 250 psi, phase 6. The injection air pressure during flow increased from 114 psi, phase 1, to 188 psi, phase 6. The pressure during non-flow periods also increased substantially from approximately 149 psi, phase 1, to 265 psi, phase 6. During phase 6 the pop-off valve blew on the foam tank. The foam handline pressure continued to rise during each phase of the test between 18 to 66 psi. During non-flow periods the pressure climbed from 157 psi, phase 1, to 233 psi, phase 6. This indicated that the foam and injection air regulators were not functioning correctly. The flow meter showed a steady increase in the flow rate as the pressure in the tank and injection air increased. The gpm increased from an average of 36 gpm, phase 1, to an average of 42 gpm, phase 5. No injection air data was recorded during this test. The pop-off valve (set to 250 psi) blew when the foam tank and injection air pressures reached 249 and 264 psi, respectively.

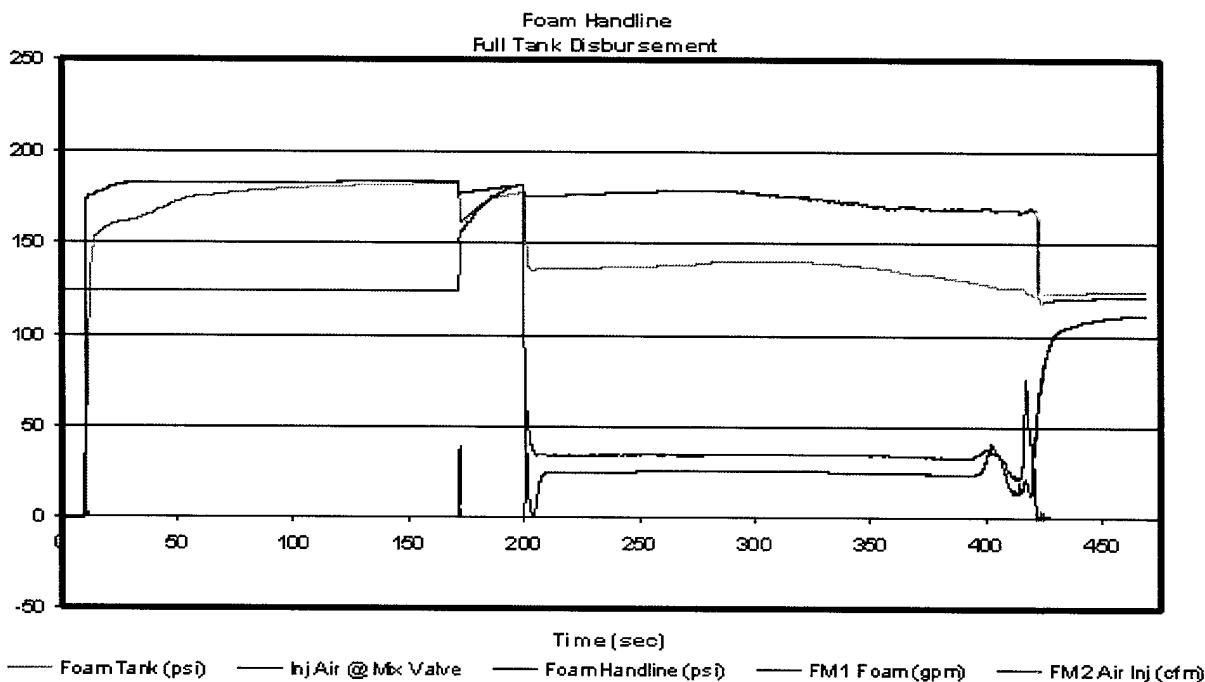
**Figure 4. Handline Foam Flow and Pressure Data, Full Tank Disbursement.**

The pressures and flow rates prior to the change of regulators are shown in Figure 4. When the foam was discharged, the foam tank pressure decreased to 176 psi and the injection air pressure decreased to 136 psi. The pressure in the foam tank showed a slight decline in pressure toward the end of the test. For this test, the regulator was functioning normally and maintaining pressure close to the set point. The pressures at the end of the test for the foam tank and injection air were 169 and 129 psi. The handline pressure was maintained at an average pressure of 24 psi. The foam flow was maintained at approximately 34 gpm throughout the test. No injection airflow was measured.

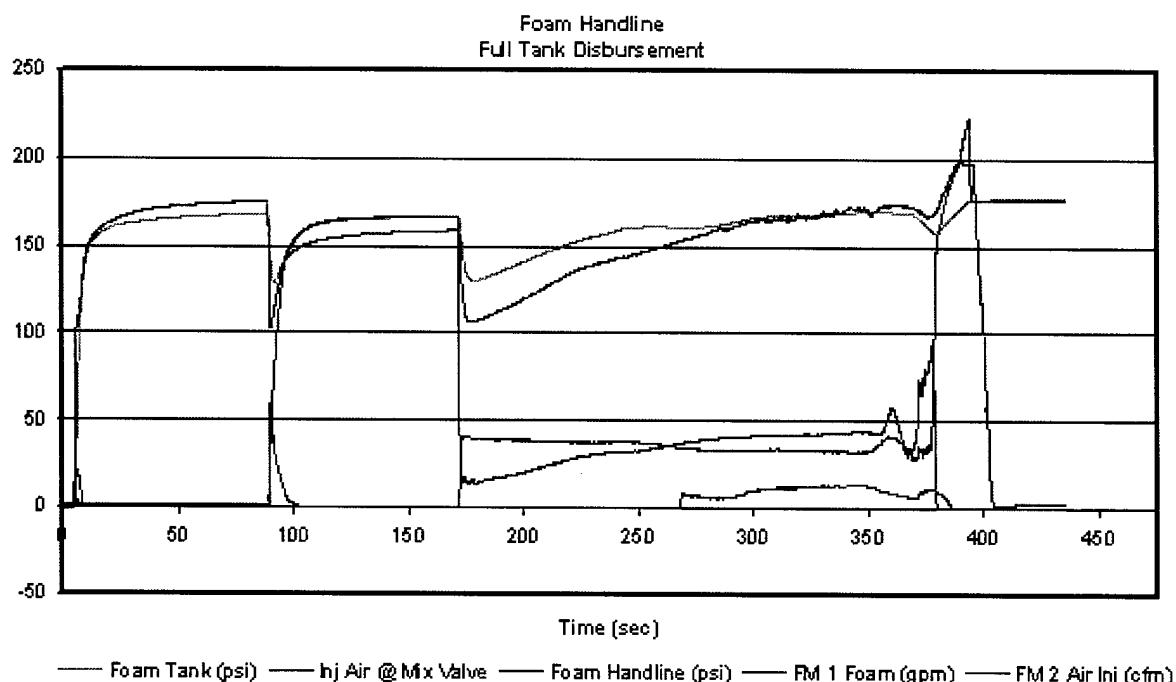
**Figure 5. Handline Foam Flow and Pressure Data, Full Tank Disbursement.**

Figure 5 shows the pressures and flow rates after the regulators were changed. The foam tank pressure was 168 psi. When the test began the foam tank pressure dropped to 130 psi, continued to climb to 161 psi, stabilized for a period of approximately 20 seconds, then climb until the end of the test to approximately 170 psi. The injection air pressure fell to 106 psi when the test began but steadily climb throughout the test and at the end of the test the injection air pressure was 174 psi. The foam flow rate decreased from 41 gpm to 33 gpm over the test duration. The injection airflow started around 6 cfm and increased to 12 cfm, however, toward the end of the test the cfm dropped again to approximately 7 cfm. The injection air became readable when the injection air pressure was within approximately 8 psi of the foam tank press.

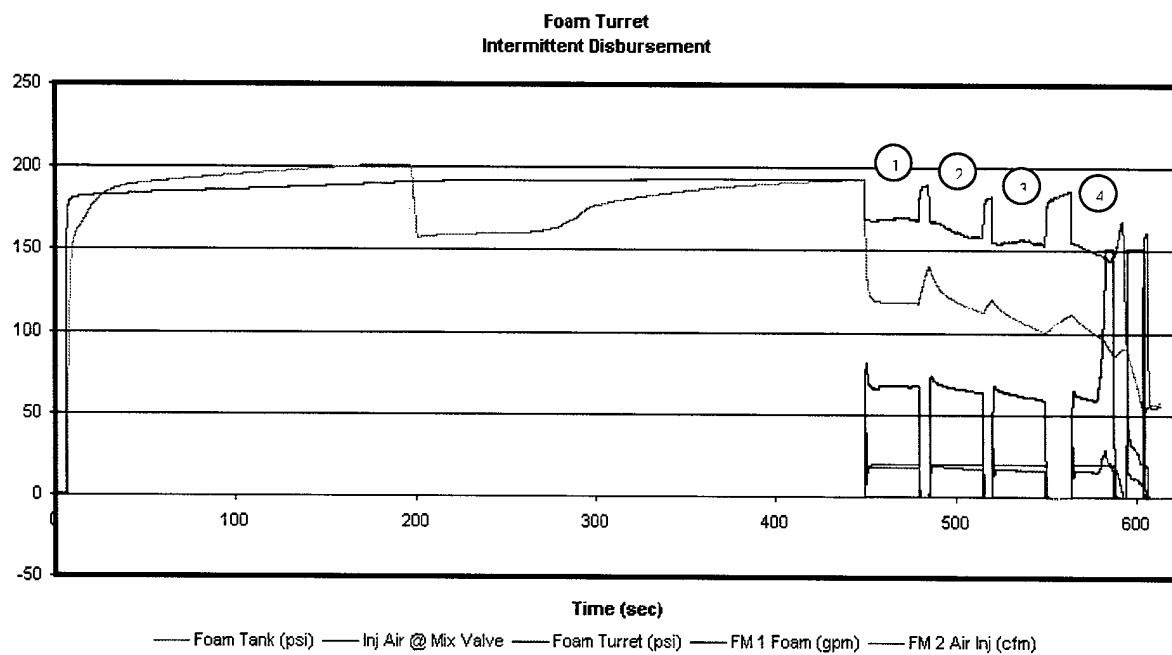
**Figure 6. Turret Foam Flow and Pressure Data, Intermittent Disbursement.**

Figure 6 shows the pressures and flow rates prior to the change of regulators. The foam tank regulator was adjusted from 200 psi to 185 psi per the manufacturer, however, over a period of 100 seconds the pressure increased to 193 psi. This indicated that the regulator on the foam tank was not working properly. When the test began the tank pressure steadily decreased from 118 psi, phase 1, to 89 psi, phase 4. The pressure at turret stayed relatively constant at 14 psi for the duration of testing. The foam flow showed only a decrease of 5 gpm from 67.4 to 62 gpm over the full discharge. The injection air flow averaged 20 cfm.

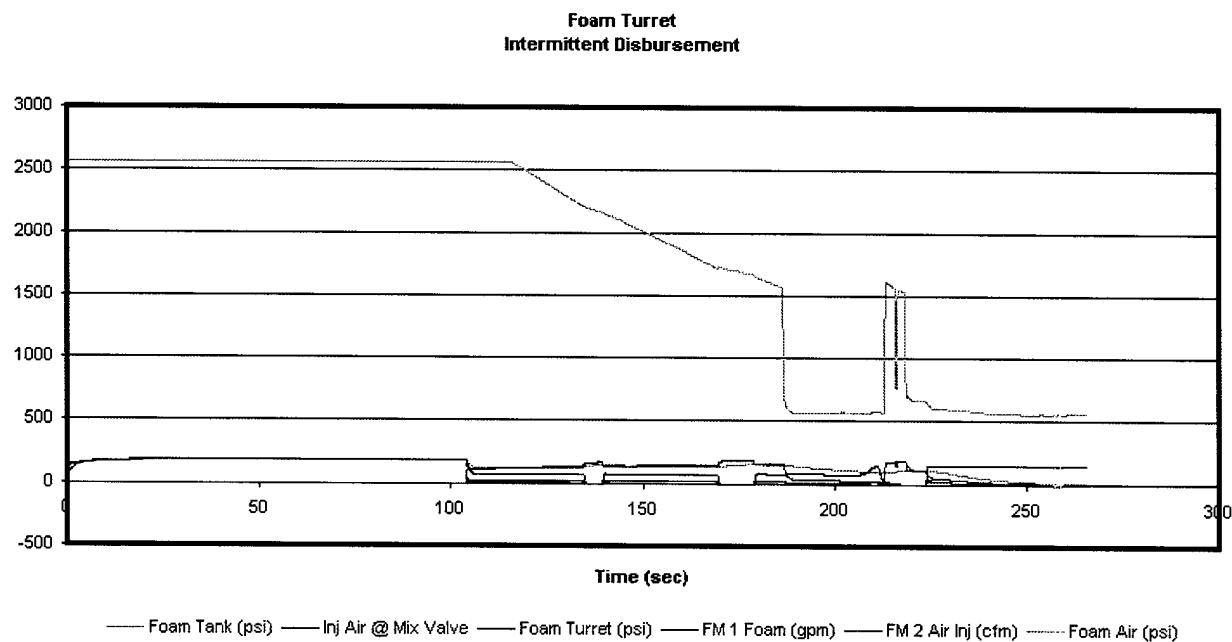
**Figure 7. Foam Air Pressure Data, Intermittent Disbursement.**

Figure 7 shows the pressures at the foam air tank after the regulators were changed. A drop in foam high pressure air tank occurred toward the end of the test. Problems with instrumentation would have caused a negative reading and therefore, was ruled out as the source. The exact cause of the drop in pressure was never determined and continued to occur with both foam and dry chemical testing. Prior to the drop the injection air pressure had increase from 140, phase 1, to 160 psi, phase 3 (Figure 8). The pressure at the turret during flow remained stable at 16-18 psi. The foam flow meter registered a flow rate of 70 gpm, phase 1, to 85 gpm, phase 3. The injection air flow meter stayed relatively constant at 18 cfm.

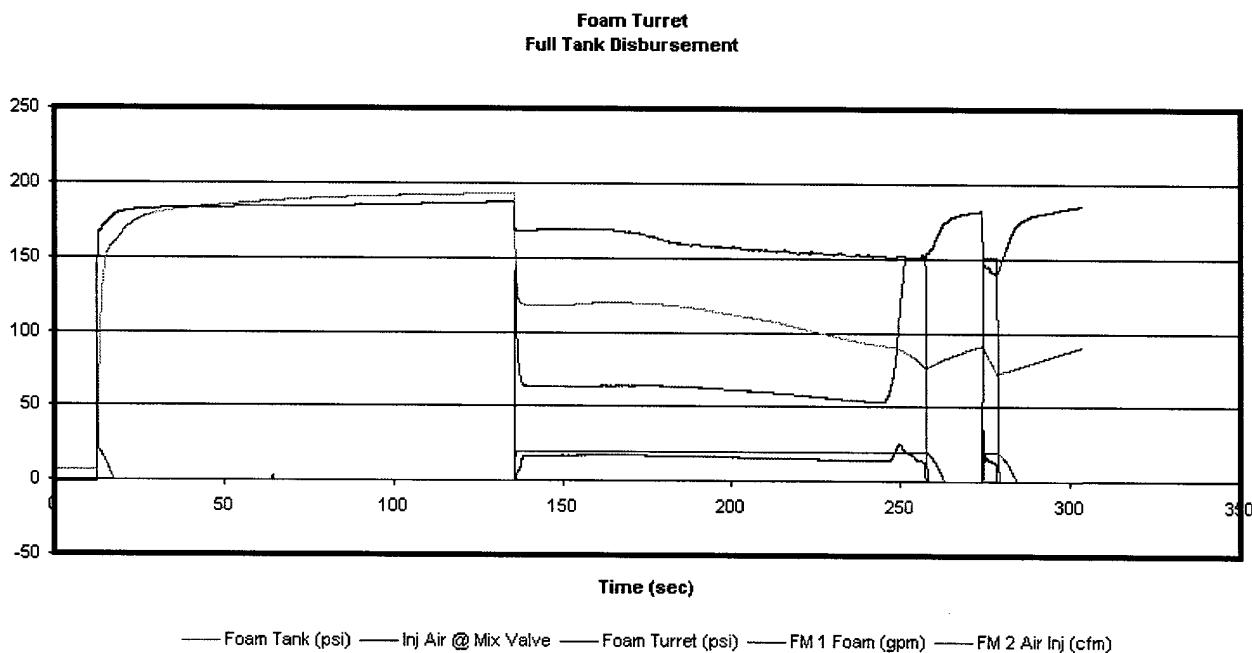
**Figure 9. Turret Foam Flow and Pressure Data, Full Tank Disbursement.**

Figure 9 shows the pressures and flow rates prior to the change of regulators. The foam tank pressure dropped from 190 psi to 118 psi during the full tank discharge. The pressure in the foam tank was not maintained and a steady decrease was observed for the full discharge. This suggests that a restriction exists in the system. The most likely source was the regulators since several other problems were experienced with that component, however, this was not confirmed by AFRL. The injection air pressure dropped from 186 to 152 psi. The foam flow during the first 27 seconds was approximately 64 gpm and steadily decreased to 53 gpm at the end of the test. The injection air stayed constant at 19 cfm. The pressure at the turret was consistent at 15-17 psi.

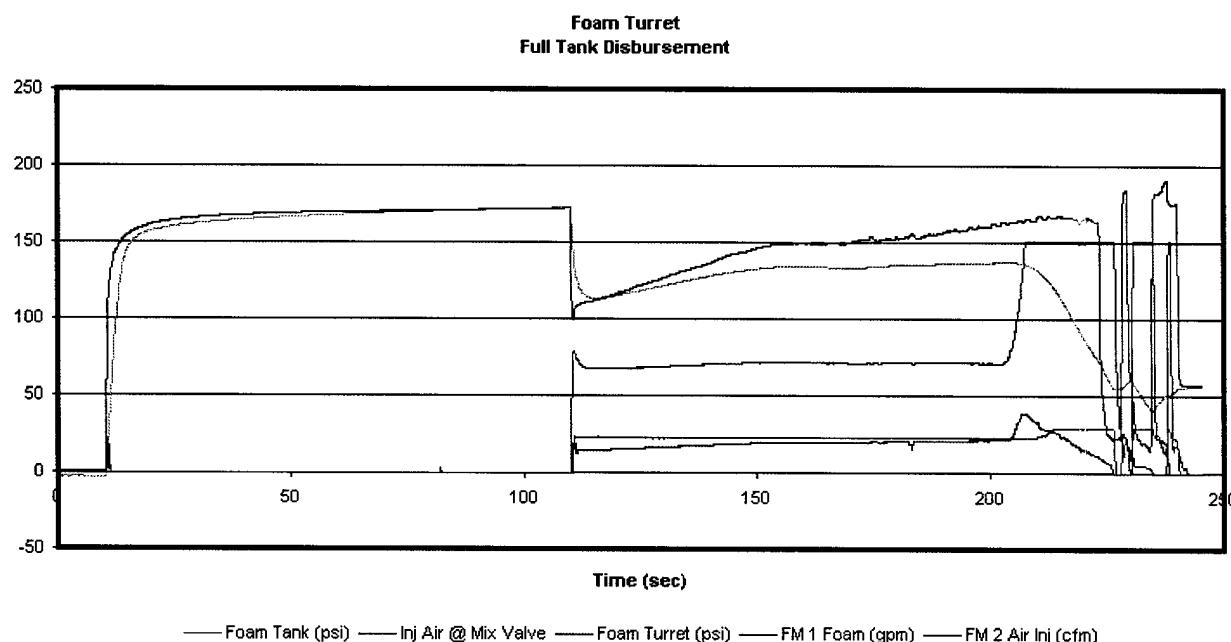
**Figure 10. Turret Foam Flow and Pressure Data, Full Tank Disbursement.**

Figure 10 shows the pressure and flow after the regulators were changed. Even though the new regulators were set to the manufacturer's specified settings, the foam tank pressure and the air injection pressure never reached the set points. The foam tank pressure reached 172 psi, decreased to 114 psi as the agent flowed then increased to 137 psi at the end. The injection air pressure increased to 167 psi after the initial drop of 106 psi. The foam flow was stable at 71 gpm, while the injection air meter maintained an approximate 23 cfm flow. The spike in the foam flow rate observed after the agent was depleted was likely due to the injection air that was still discharging, causing a faulty measurement. The turret pressure showed an increase from 12 to 19 psi. The injection air pressure continued to climb slightly even after the agent was depleted.

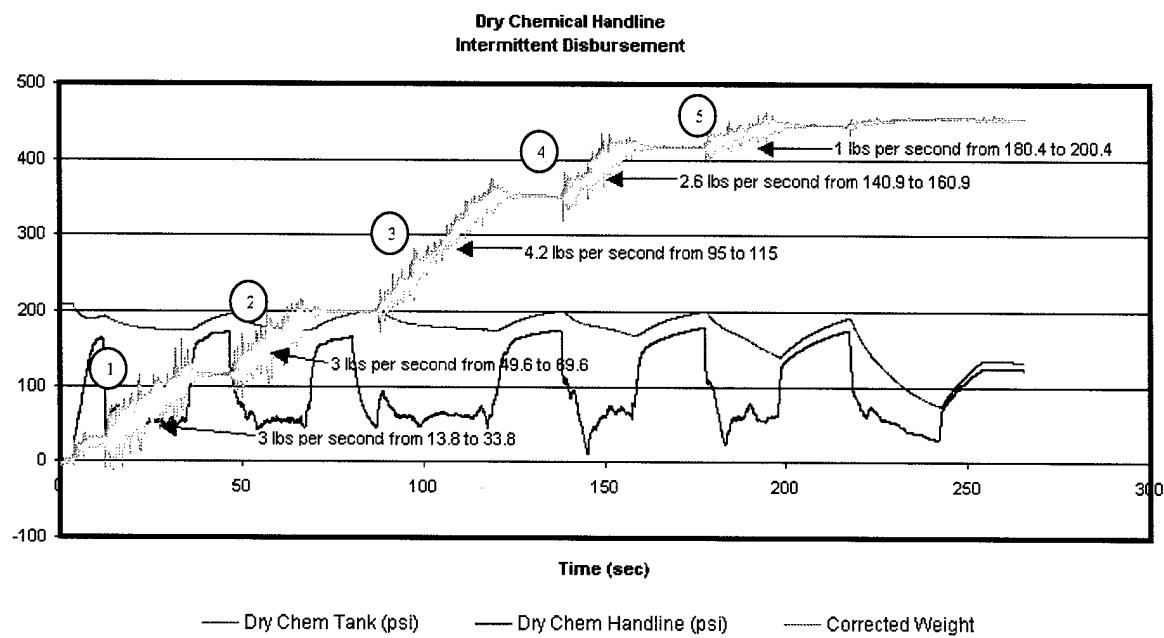
**Figure 11. Handline Dry Chemical Flow and Pressure Data, Intermittent Disbursement**

Figure 11 shows the pressures and flow rates prior to the change of regulators. The dry chemical tank pressure prior to the opening of the handline was approximately 209 psi. Five phases were completed during this test. The pounds per second used for each phase of the test averaged 3, 3, 4.2, 2.6 and 1. When the handline was charged, the pressure dropped to 189 psi and quickly climbed (time 5 seconds) to 192 psi. For the first three phases of flow testing, the dry chemical tank pressure remained at 175 psi. During the last two phases, the pressure dropped to 169 and 143 psi respectively. During non-flow periods the pressure remained between 191-201 psi. During the first two flow periods the handline pressure was approximately 54 psi, however, as the flow rate decreased the pressure on the handline increased to 60-70 psi.

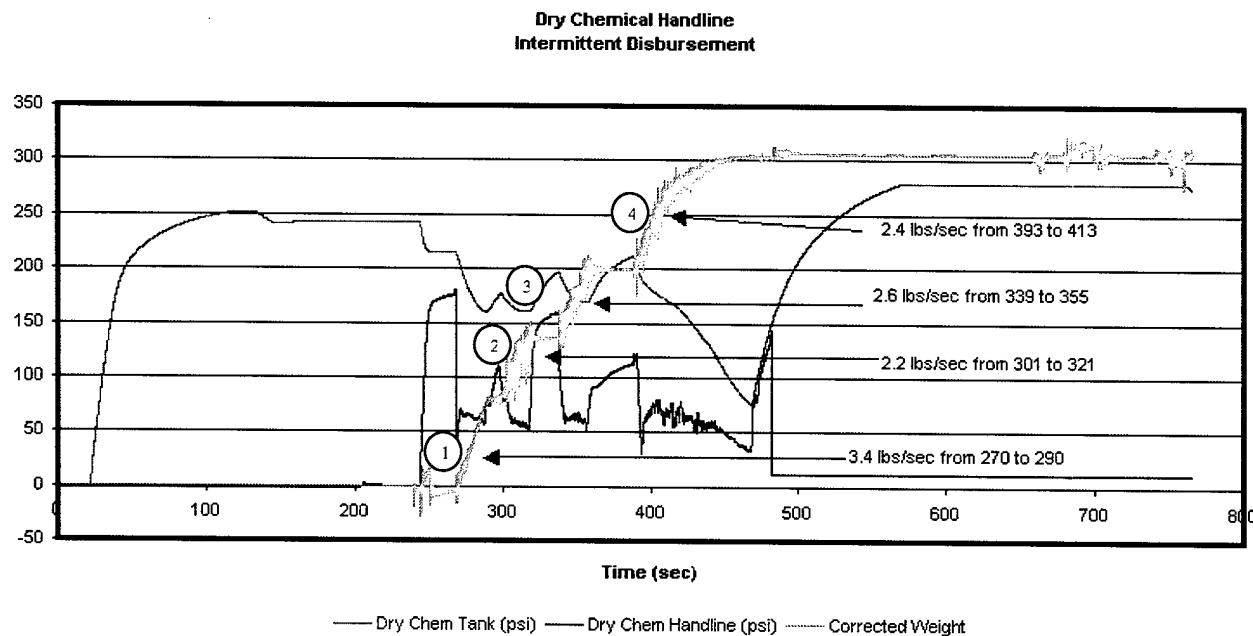
**Figure 12. Handline Dry Chemical Flow and Pressure Data, Intermittent Disbursement.**

Figure 12 shows the pressures and flow rates after the regulators were changed. During the four test phases, the dry chemical flow rate was more consistent and averaged 3.4, 2.2, 2.6 and 2.4. The dry chemical tank pressure exceeded the 225 psi set point during the test and had to be manually corrected prior to the next test. The pressure dropped from 242 to 214 psi when the handline was charged and remained at this pressure until the test began. During the flow period the dry chemical tank pressures were 161, 164, 170, and 77 psi and during non-flow periods the pressures were 174, 196, 211 and 278 psi. When the dry chemical tank pressure reached 278 psi the system was cut off. Figure 13 shows the foam and the dry chemical air tank pressures during this test. The foam air tank continued to lose pressure throughout the test, while at the beginning of the test the dry chemical air tank increased slightly. During the test, the foam air tank was also decreasing in pressure and after the test had ended the foam air tank continued to lose pressure, which indicated that the foam air tank was still feeding the dry chemical tank. Again, the foam and dry chemical systems are independent of one another according to the manufacturer although they behave as though they are connected. The handline pressure, when the handline was charged was approximately 177 psi and varied during agent flow. During phase 1 the flow pressure fell from 67 to 58 psi; phase 2, 58 to 53 psi; phase 3, 61 to 57 psi; and phase 4, 70 to 34 psi. The non-flow periods the handline pressure was 107, 157, 91 to 114, and 138 psi.

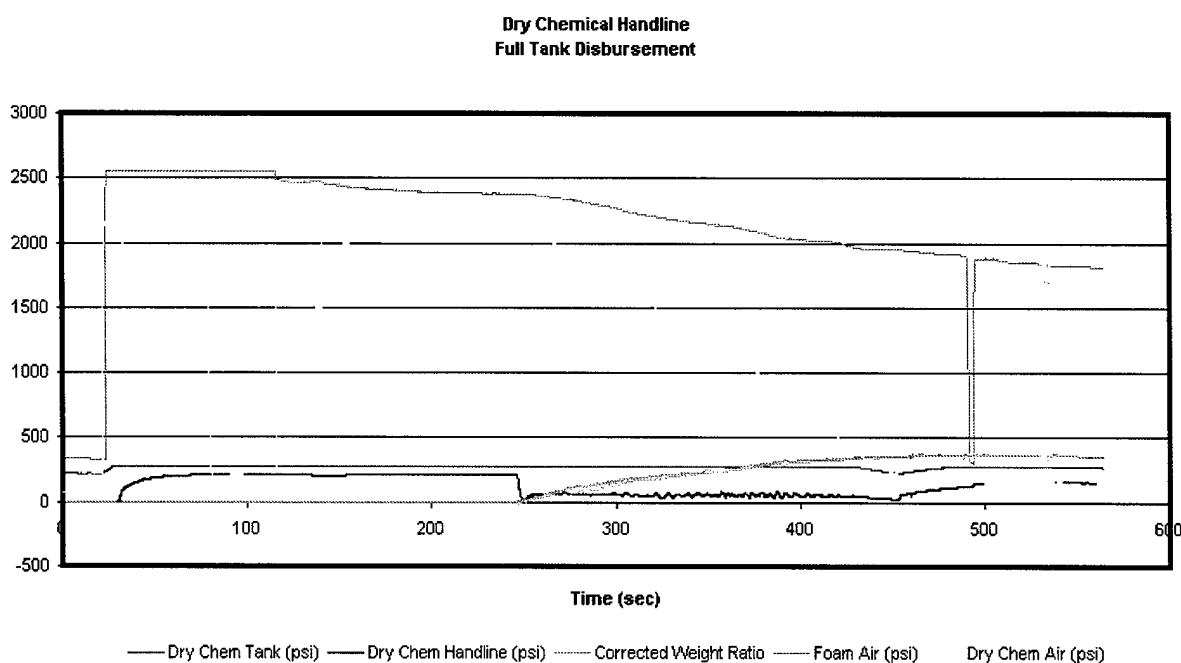
**Figure 14. Air Tank Pressure Data, Full Tank Disbursement.**

No dry chemical handline, full tank disbursement tests were conducted prior to the change of regulators. Figure 14 shows the air tank pressures for the foam air tank and the dry chemical air tank with the new regulators. Two drops in air pressure on the dry chemical air tank occurred during testing. One while the handline was charged, the other during agent flow. Flow and pressure measurements shown in Figure 15 do not indicate any change in the performance. Note that, as seen in the previous test, the foam air pressure continued to decrease throughout the test, while the dry chemical air increased slightly at the beginning. This indicated that the air from the foam air tank (higher pressure) was bleeding into the dry chemical air tank (lower pressure). The dry chemical tank pressure remained constant at 278 psi throughout the test even though the regulator was set at 225 psi. This constant pressure was not seen in any other test performed. The pressure on the handline nozzle was approximately 213 psi prior to the beginning of the test. When the test began, the average pressure on the handline was approximately 59 psi. The approximate discharge of dry chemical was three pps.

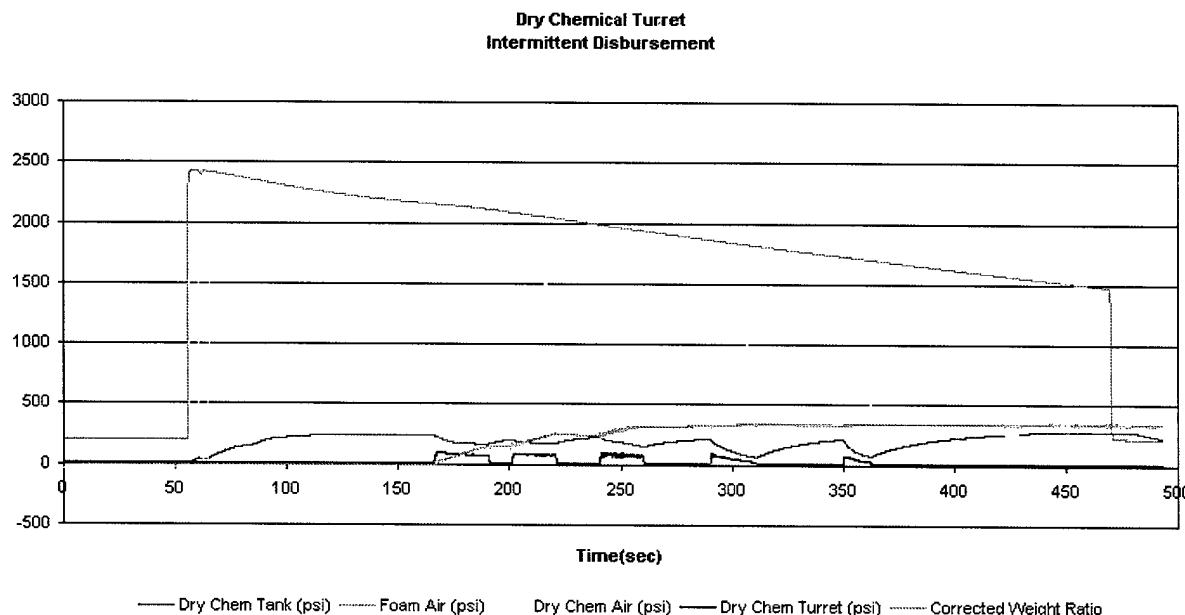
**Figure 16. Air Tank Pressure Data, Intermittent Disbursement.**

No tests were completed on the dry chemical turret prior to the change of the regulators. Figure 16 shows another unexplained pressure drop at the dry chemical air tank when the system was charged. The foam air tank showed a constant decline in pressure over the testing period. The dry chemical air tank showed a sharp drop in pressure after the system was charged. The dry chemical air tank pressure continued to drop until the dry chemical tank pressure (Figure 17) reached approximately 221 psi. At that point, the dry chemical air tank pressure started to increase until the agent was flowed. During each phase of the test the dry chemical air tank pressure continued to drop. The dry chemical tank pressure, once charged, increased to 238 psi. When the test began, the dry chemical tank pressure dropped to 171, 176, 152, 66 and 76 psi. The dry chemical tank pressures during non-flow periods were 198, 222, 212, 211 and 278 psi. The system was turned off at this point to prevent over pressurizing the system. The foam tank pressure during this test was 240 psi even though no foam was flowed. The turret pressures during phase 1, decreased from 97 psi to 73 psi and during phase 4 the pressure dropped from 93 to 20 psi. The dry chemical flow rate averaged 5.2, 4.5, 3.1, 0.6 and 0.5 pps. Little dry chemical was being disbursed after the third phase of the test even though only 262 lbs out of 500 lbs had been discharged. AFRL could not find an explanation for this result.

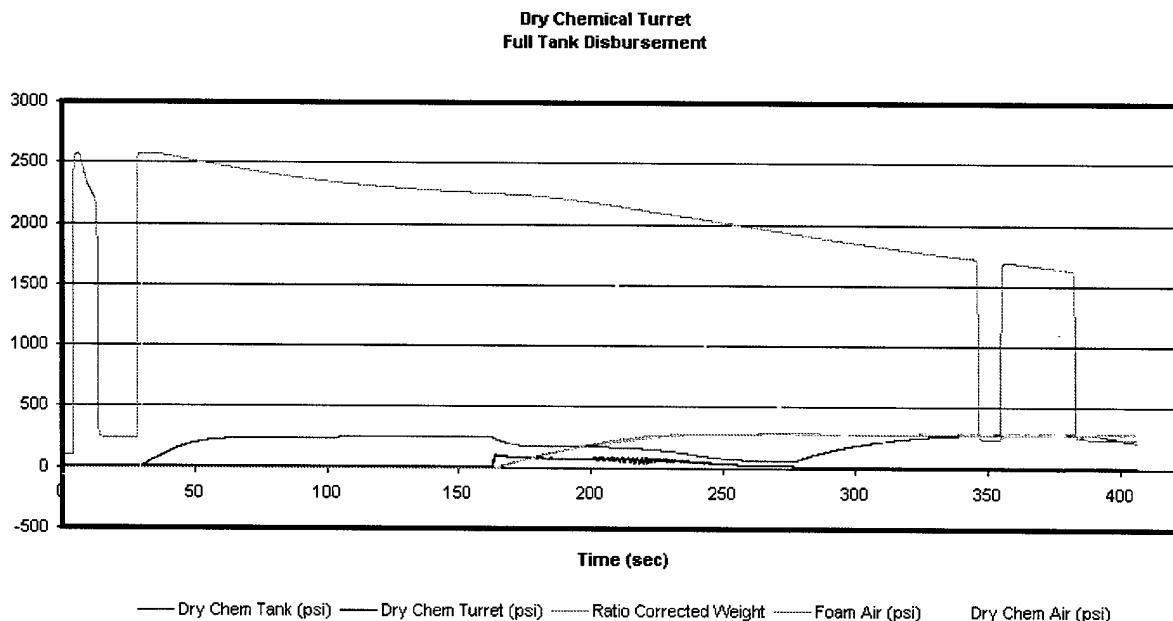
**Figure 18. Air Tank Pressure Data, Full Tank Disbursement.**

Figure 18 showed a drop in foam air tank pressure at both the beginning and end of the testing period. Over the testing period, the foam air tank pressure continued to drop. As with the previous testing, the dry chemical air tank pressure decreased until the dry chemical tank reached 235 psi, then increased in pressure until the test began. The foam tank pressure was maintained at 250 psi until the end of the test when the pressure increased to 261 psi (Figure 19). The dry chemical tank pressure reached 250 psi prior to the beginning of the test. The foam turret pressure decreased from 101 psi to 20 psi over the test period. The dry chemical used was approximately 4.9 lbs/sec (average from 172 to 202 seconds) for a total of approximately 147 lbs of the 500 lbs available. The majority of the dry chemical was not discharged before the pressure in the air tank was depleted. This significantly reduced the application time of the agent from 100 seconds (estimated) to 30 seconds (actual).

The volume of compressed air need to drive the dry chemical turret operation needs to be recalculated.

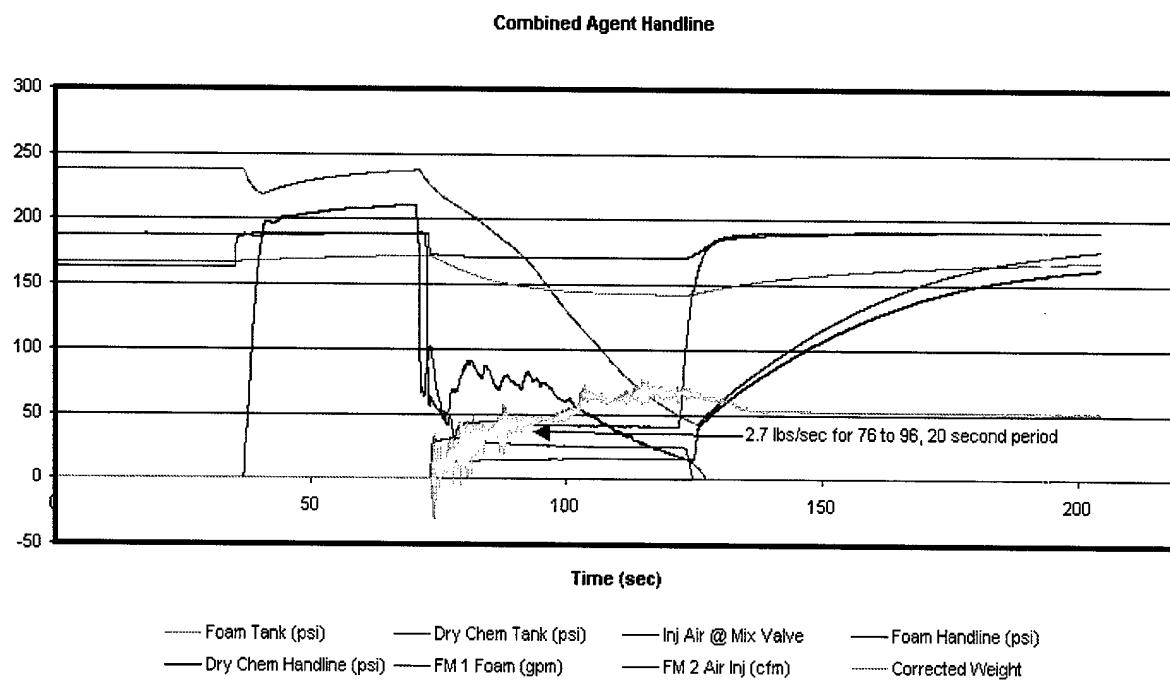
**Figure 20. Foam Flow and Pressure Agent, Combined Agent Handline Disbursement.**

Figure 20 shows the pressures and flow rates prior to the change of regulators. The initial dry chemical tank pressure was 237 psi and decreased to 219 psi when the handline was charged. The foam tank pressure increased to 167 psi before the handline was charged indicating a leak in the regulator. The foam flow rate was approximately 35 gpm and the dry chemical flow rate was 2.7 pps.

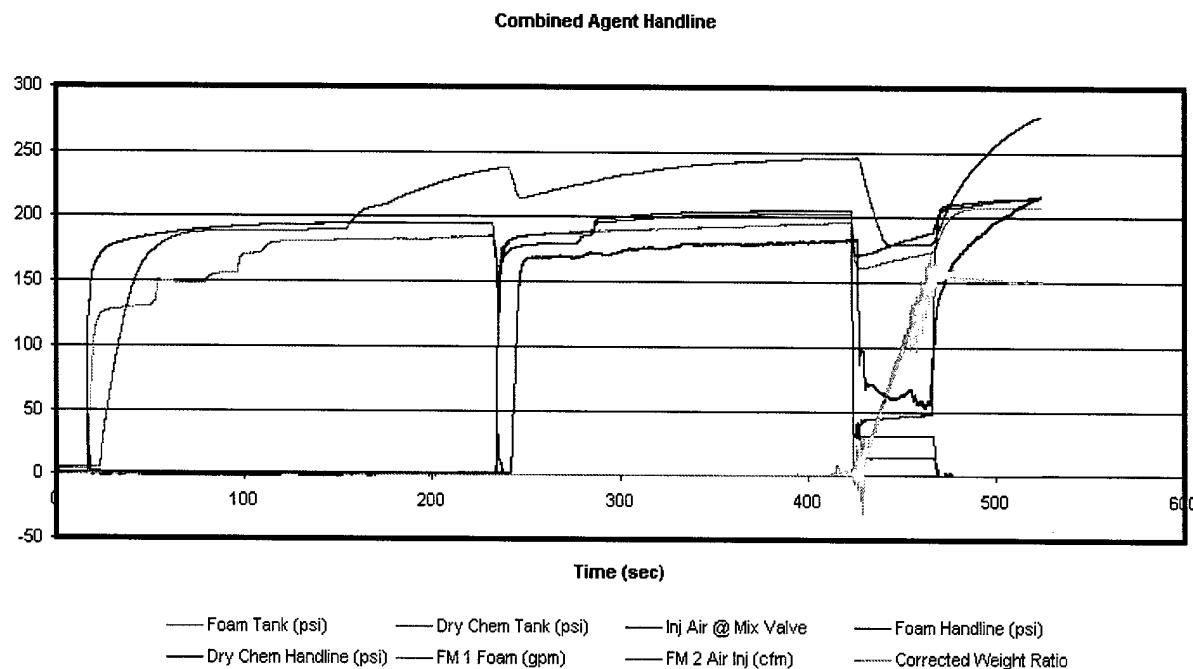
**Figure 11. Foam Flow and Pressure Data, Combined Agent Handline Disbursement.**

Figure 21 shows the pressures and flow rates after the change of regulators. The adjustments to the foam tank pressure and dry chemical pressure are seen on the data prior to the test start. After the test was completed, the foam tank pressure continued to build. The pressure in the foam tank increased to over 280 psi before the system was shut down manually. This not only indicated a problem with the regulator but also a problem with the pressure relief valve, which is suppose to activate at 250 psi. This is a serious safety concern and should be addressed in future systems. The amount of dry chemical flow rate averaged 4.2 pps.

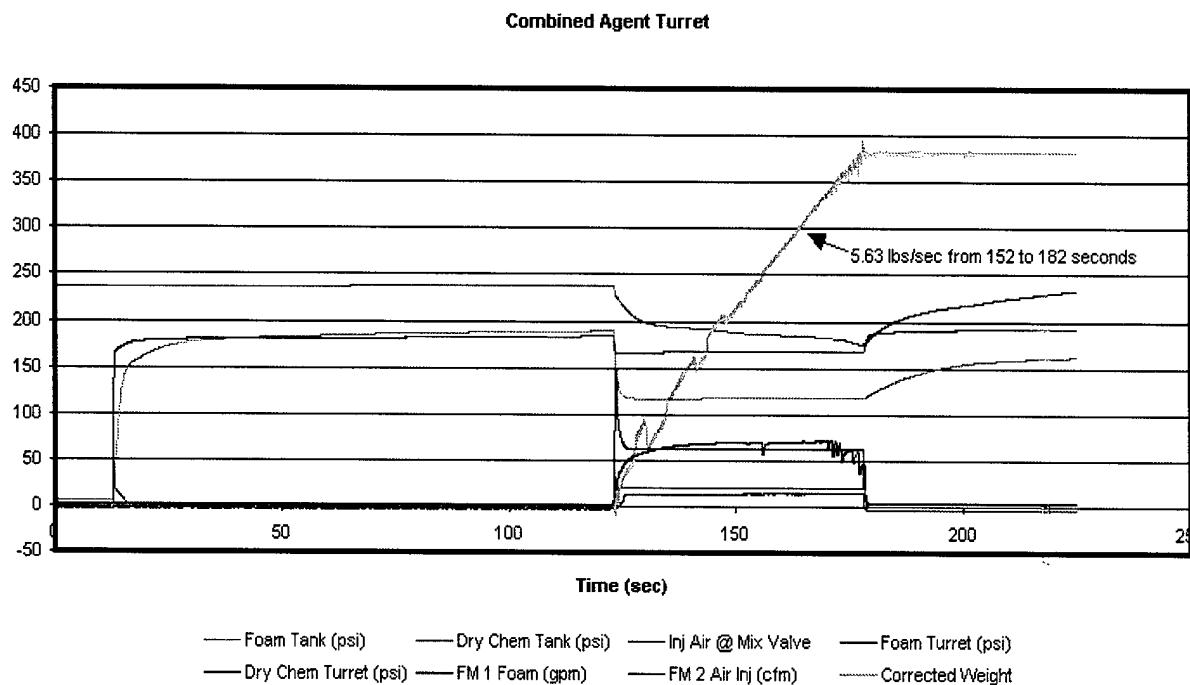
**Figure 22. Foam Flow and Pressure Data, Combined Agent Turret.**

Figure 22 shows the foam flow and pressure data for the combined agent test prior to the change of regulators. The foam flow averaged 55 gpm and the dry chemical flow averaged 5.63 pps. The foam tank pressure was maintained throughout the test at approximately 120 psi while the dry chemical tank pressure steadily decreased from 240 psi to 180 psi.

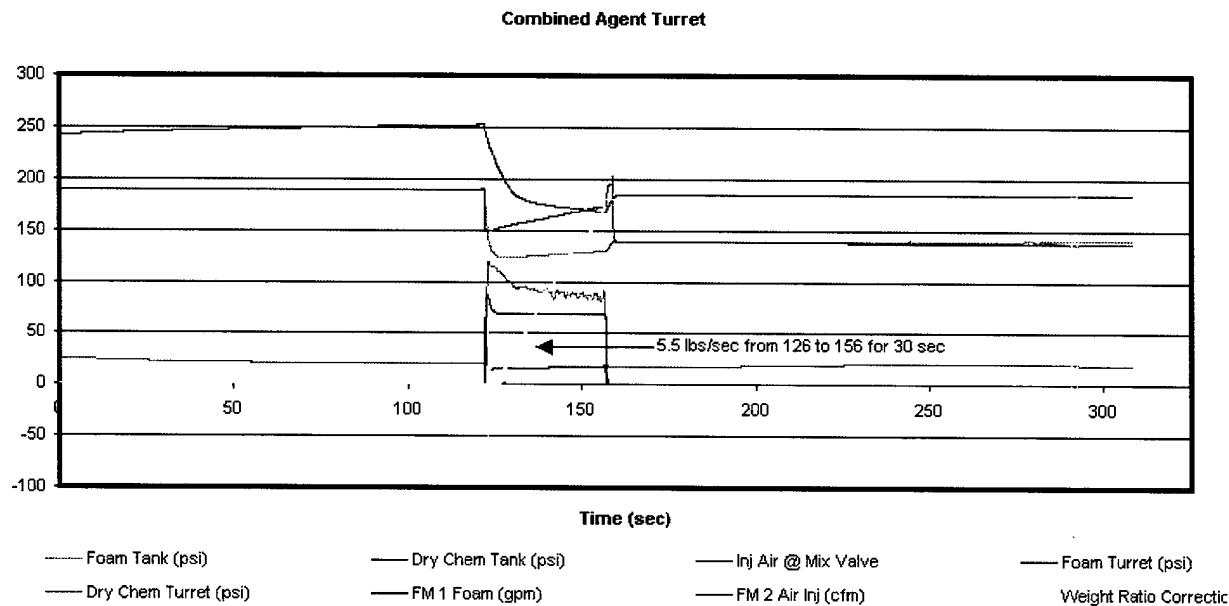
**Figure 23. Foam Flow and Pressure Data, Combined Agent Disbursement.**

Figure 23 shows the foam flow and pressure data after the regulators were changed. Foam flow rate decreased with the replacement regulators from 55 gpm to 20 gpm. The dry chemical flow rate stayed the same at 5.5 pps. The pressure on the dry chemical tank decreased from 250 psi to 170 psi during testing. The foam tank pressure increased slightly from 125 psi to 130 psi.
